**INSPECTION  
SERVICES**

# **UTILITY ASSET INSPECTIONS FROM THE INDUSTRY EXPERTS**

## MIDDLE TENNESSEE ELECTRIC PARTNERS WITH PLP TO INSPECT INFRASTRUCTURE ASSETS IN RURAL AREAS

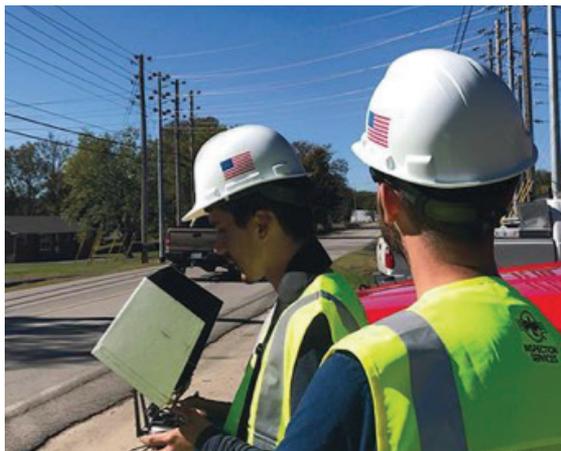
As an added safety measure, PLP pairs a visual observer (a person dedicated to continuously monitoring the drone's path) with each drone pilot.

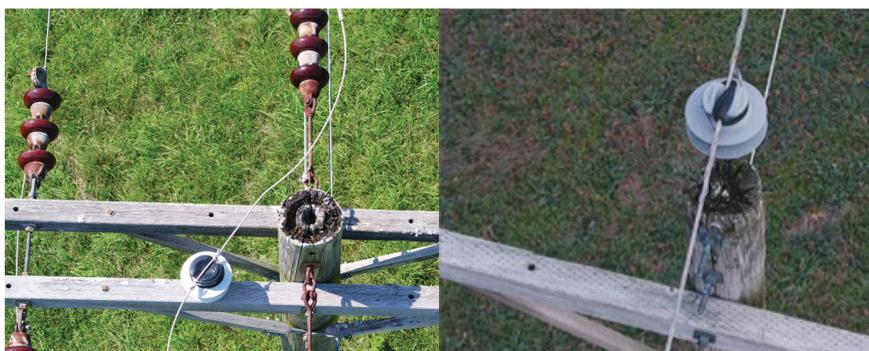
The drone inspection conducted by PLP discovered severe rot on the top of several poles.

Initially, the group found such issues as hollowed-out poles from woodpecker damage and bolts hanging by the outside of the poles. Also, the drone images revealed chipped insulators, fungus growth on top of the poles, water egress and pole top rot and split crossarms. To discover hot spots, PLP used high-tech infrared cameras, which could find loose connections on devices and splices that had issues.
